Record of significant findings	
Building Location :	Inspection undertaken by :
Lower School Pavilion	Nigel Billing CMIOSH Date: 17/05/18
Background	<p>The pavilion is currently undergoing major refurbishment to convert the ground floor into a pre-prep school. The first floor consists of two rooms, currently used as site office and storage for the refurbishment project. It is intended to revert the first floor back to use as pupil changing rooms whilst the ground floor project is ongoing.</p> <p>This inspection looked at the considerations that need to be in place to ensure the first floor can be safely used whilst the work is ongoing.</p>
RECOMMENDATIONS	
	Completed When?
An access route is to be provided to the concrete staircase from the field, ensuring the remainder of the work area is inaccessible to pupils. The heras fencing creating the route must be secured to the building on both sides at the foot of the staircase rather than just pushed against the sides, to ensure it cannot be easily moved aside.	Completed and removed 2018 GB

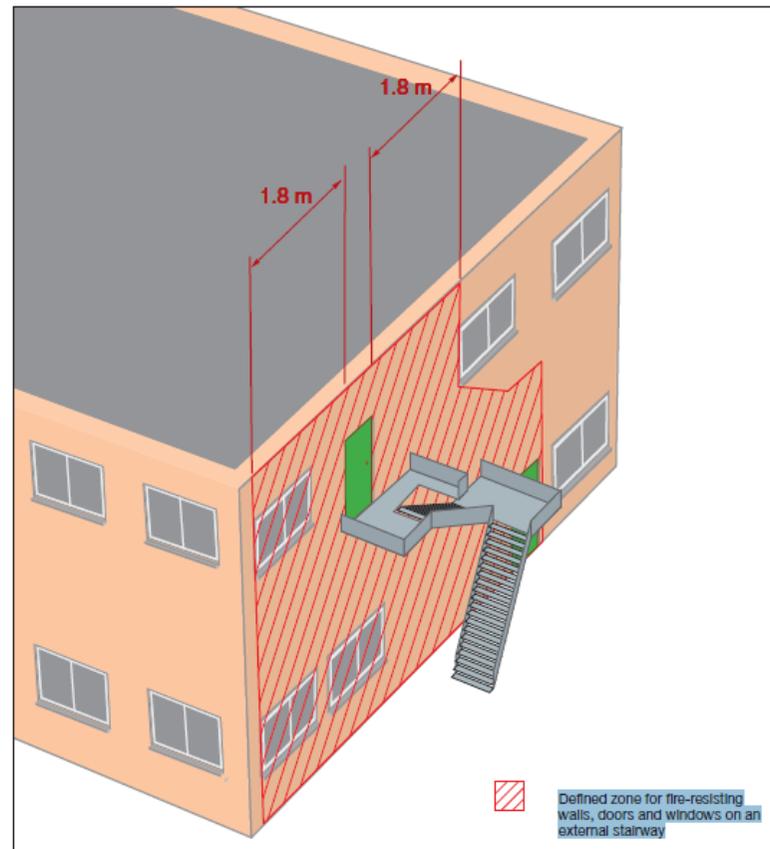
Figure 37: Protection to an external stairway

To be considered a viable escape route, an external stairway should normally be protected from the effects of a fire along its full length. This means that any door, window (other than toilet windows) and walls within 1.8m horizontally and 9m vertically below any part of the stairway should be fire-resisting. Windows should be fixed shut and doors self-closing (see Figure 37).

The current building opening adjacent to the staircase must be infilled before the staircase is used by pupils. This and the proposed adjacent window (unless it is to a toilet) must provide 30 minutes fire resistance, and the window must be fixed shut in accordance with fire safety guidance (see following extract).	Completed 10/09/19 GB
